**Project** Coventry Road, Cawston,  
Phase 2

**Title** Site Location Plan

**LAND SOUTH OF CAWSTON LANE, SOUTH RUGBY**

**SITE INVESTIGATION FACTUAL REPORT**

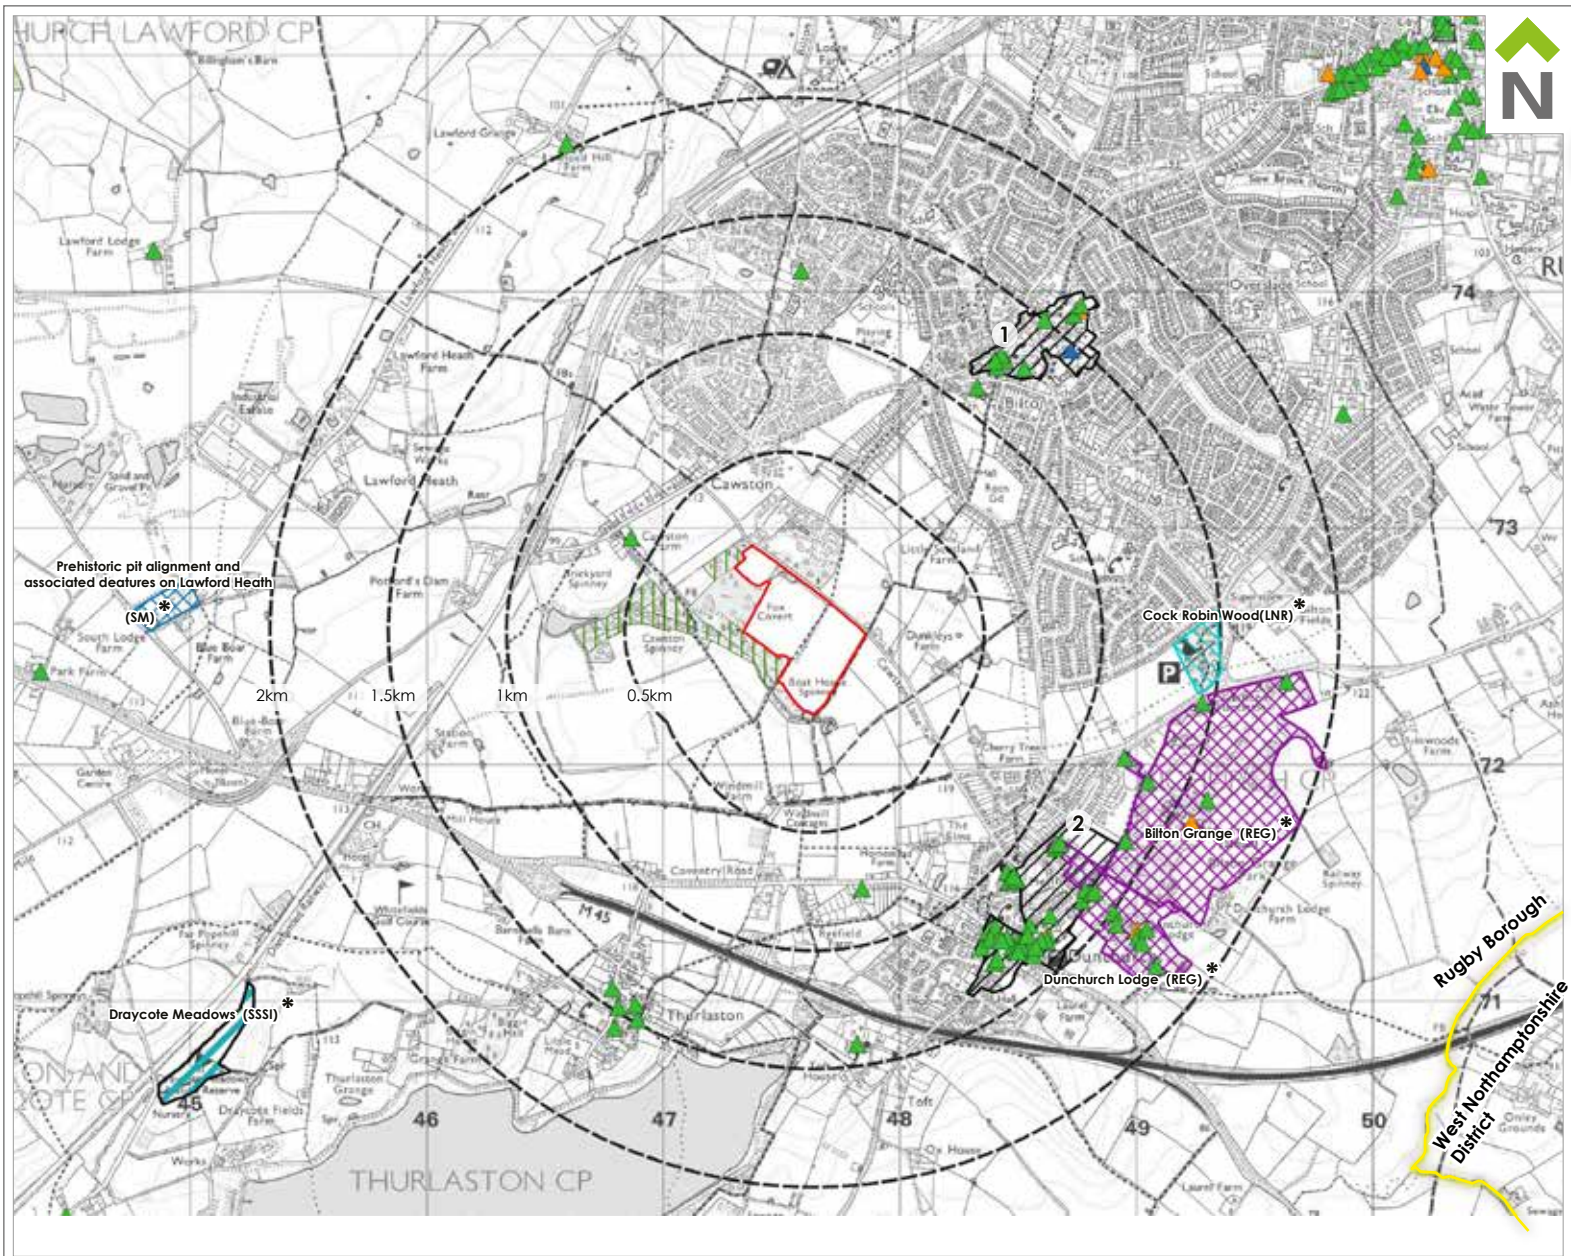
**Drawing Title** Designations and Local Policy Plan

- Site Boundary
- District Boundary
- Conservation Areas
  - 1. Bilton
  - 2. Dunchurch
- ▲ Grade I Listed Buildings & Structures
- ▲ Grade II\* Listed Buildings & Structures
- ▲ Grade II Listed Buildings & Structures
- Scheduled Monuments (SM)
- Registered Parks and Gardens (REG)
- Site of Special Scientific Interest (SSSI)
- Ancient Woodland
- Local Nature Reserve (LNR)
