RUGBY BOROUGH COUNCIL

WOLSTON
CONSERVATION AREA APPRAISAL

June 2010

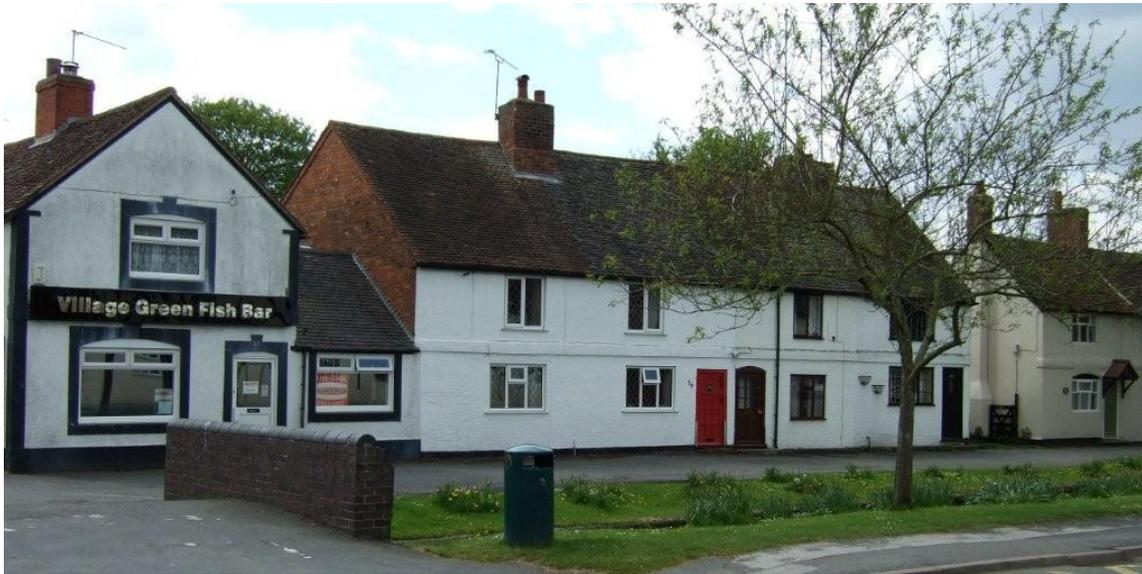
Photograph 3 Village greens providing the foreground to buildings

As the series of greens end Main Street runs to the east of The Beeches. A narrow drive lies to the west and runs along the western side of the paddock, serving a small number of houses, the school and church. Buildings continue on the eastern side of Main Street, with two long terraces dominating, set behind long front gardens. North of the River Avon the countryside character dominates with only occasional buildings.

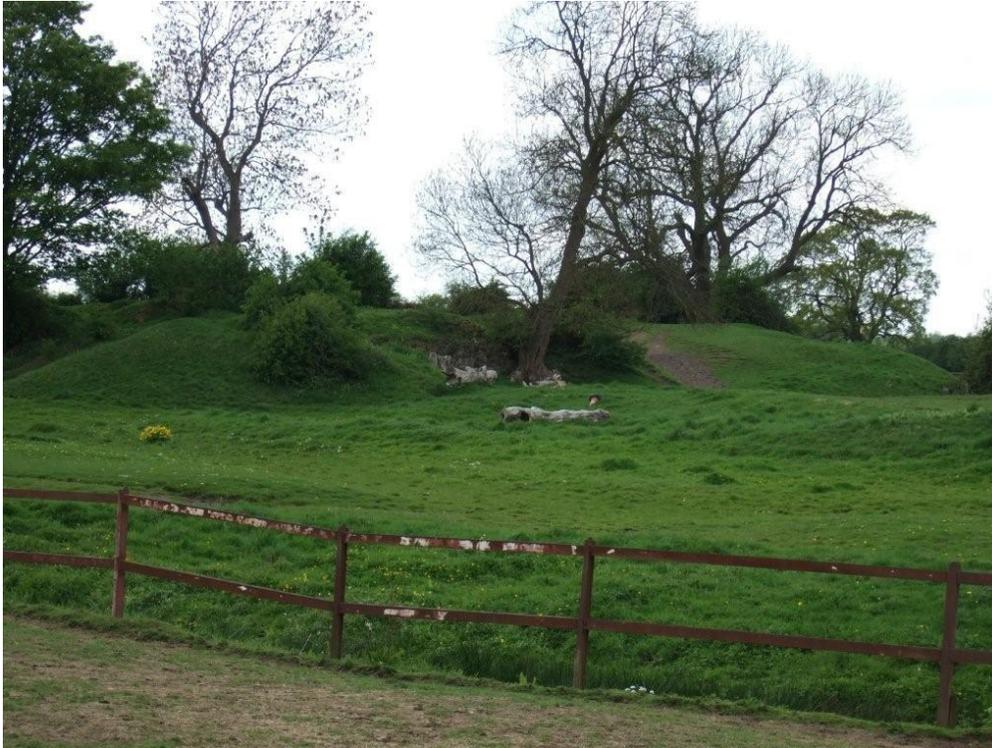
Photograph 5 Remains of Brandon Castle

On the northern side of the River Avon are extensive earthworks that mark the site of Brandon Castle. This was built in the twelfth century and was the seat of the Verdun family. It was said to have been pulled down by the baronial troops from Kenilworth Castle in 1265 because John de Verdon was an active supporter of the king. Reportedly it was repaired and used as a holding castle and park and was still a residence in 1309. Only earthworks and a few small fragments of rubble remain. Excavations however proved that the castle would have had an oblong keep.

This runs into the remains of Brandon Castle. A series of humps and bumps, the raised central area is surrounded by trees and shrubs. The area has a backdrop of mature trees which in the distance provide a sense of enclosure after the open foreground of fields.

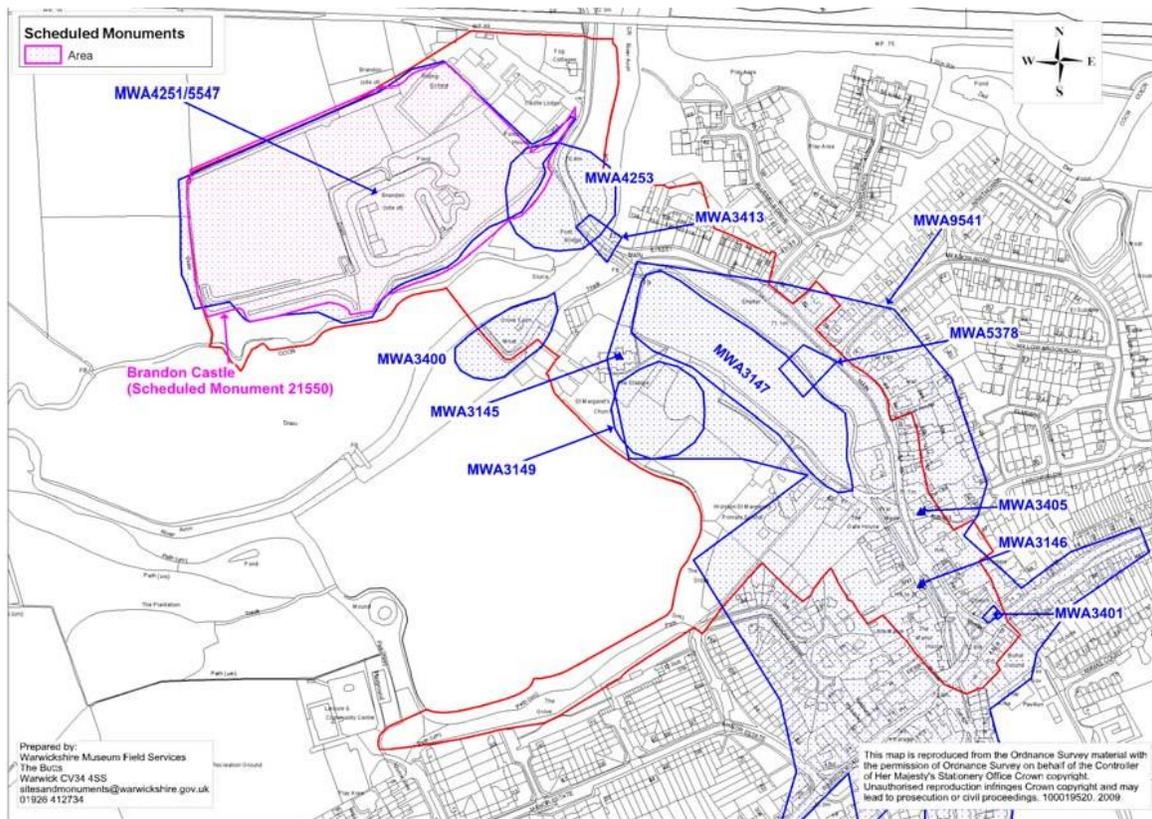
MAP 3A Archaeology recorded on the Historic Environment Record

- MWA3145 Church of St Margaret, Wolston
- MWA3405 Smithy 300m SE of Church, Wolston
- MWA3146 The Manor House, Wolston
- MWA4251 Brandon Castle
- MWA4253 Site of Medieval Watermill to E of Brandon Castle
- MWA3413 Wolston Bridge
- MWA3400 Moat 100m NW of Church
- MWA3149 Site of Wolston Manor House
- MWA3147 Shrunken Post Medieval Settlement
- MWA5378 Post Medieval Bridge, 200m E of Church
- MWA9541 Wolston Medieval Settlement
- MWA3401 Baptist Church, Main Street, Wolston

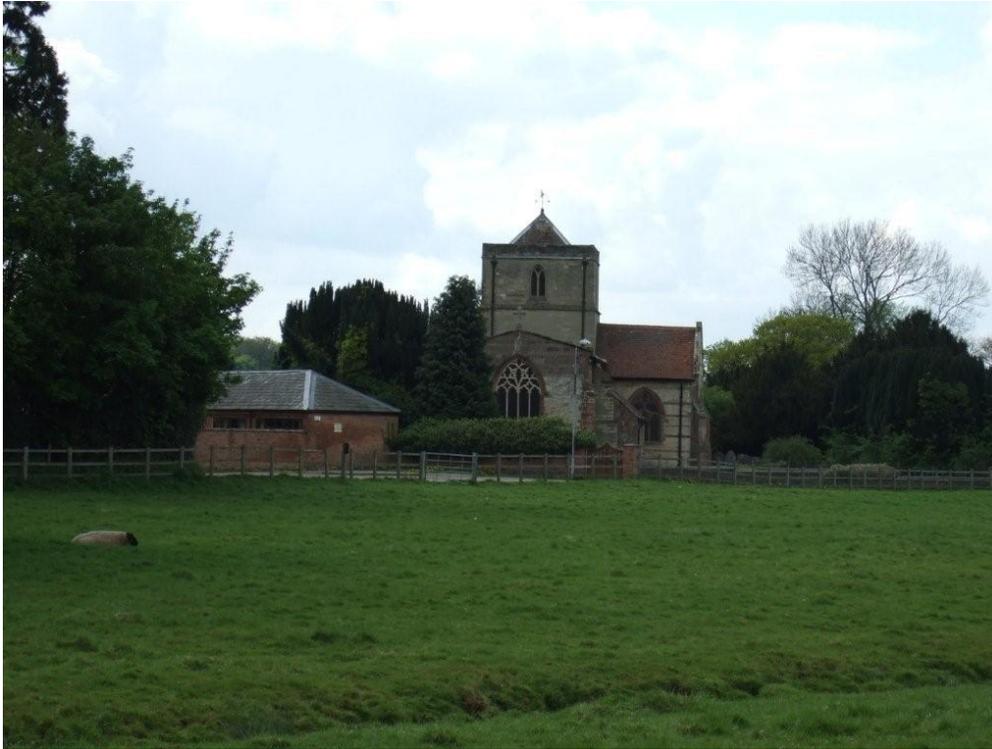
Photograph 6 The Church

The most important of these buildings is the Church of St Margaret. The building has twelfth century origins, a chancel of around 1300 with the remainder rebuilt during the fourteenth century. The clerestory was added in the fifteenth century, the tower rebuilt in 1760 and the vestry built in the eighteenth century and restored in 1860. The chancel, aisles, transepts and nave comprise coursed limestone rubble with red sandstone dressings. The transepts are partly rebuilt in coursed squared limestone with bands of red sandstone ashlar. The clerestory and vestry comprise regular coursed sandstone and the tower of sandstone ashlar.

The church has a fine setting with the paddock to the foreground providing open and attractive views of the church from the village. The rural nature is enhanced by the long paths that lead to the church from Main Street and the backdrop of mature trees. The church appears almost separate from the main part of the village. To the rear are two more modern ancillary buildings. The later, of red brick, has a more sympathetic design, the earlier yellow brick building is set too close to the church. However, both buildings are to the rear and do not unduly affect its setting. The land to the rear has a parkland appearance of undulating grassland with views terminated by the planting on the field boundary.

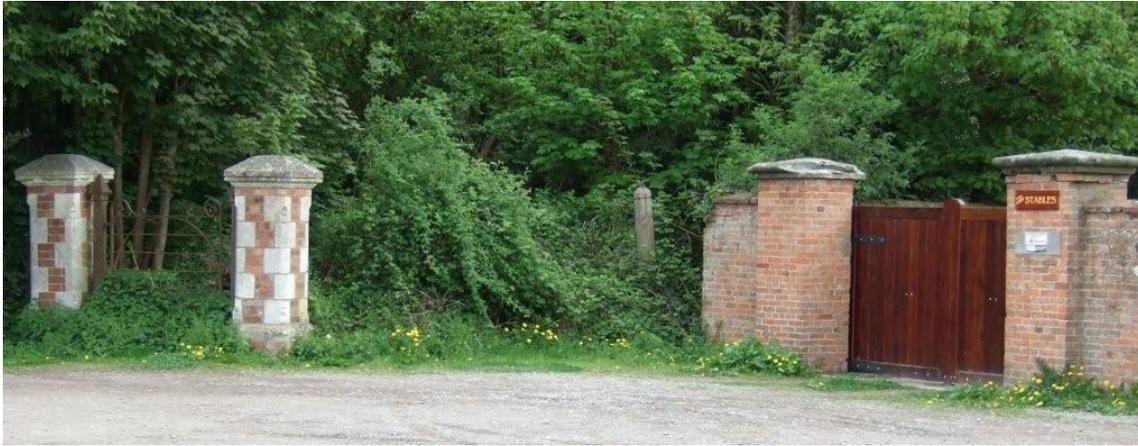
Photograph 7 Gates serving the former Manor and stables

From the south the church is read in conjunction with the converted stables. The building is single storey of red brick with slate laid in diminishing courses. A red brick wall provides the boundary and prevents clear views into the site. The former stable building is linked to the adjacent pairs of gate piers. Two sets of piers, of stone and brick with stone caps and ornate metal gates, are highly decorated and indicate access to a prominent building. The entrances are now overgrown with shrubs and trees. However, they would formerly have given access to Wolston Manor; part of the site now accommodates the school. To the rear of the school the Grove and Plantations Woodlands provides a further link to the history of the site. The narrow strip of woodland was part of the grounds to

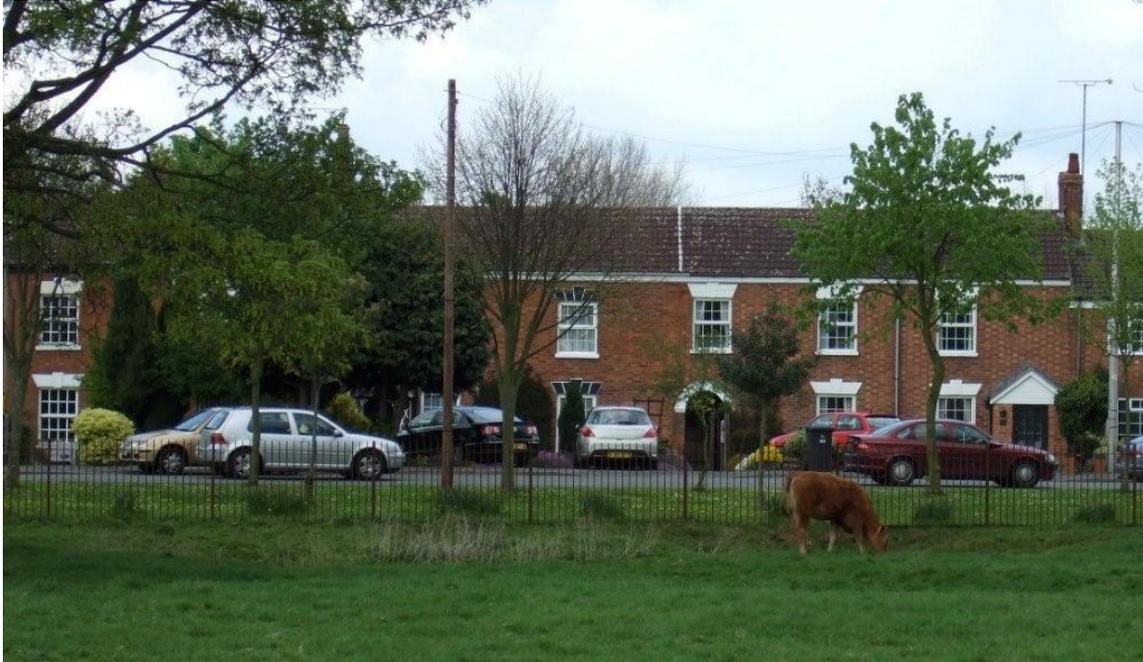
Photograph 8 Terracing on Main Street

The overriding characteristic is of variation on a theme. The terracing shares similar front building lines, setting, materials and heights. Yet within this framework there are a number of variations. In the southern terrace numbers 88 to 90 are set forward with prominent brick porches, stone lintels and a concrete

tile roof. The building has greater prominence due to the siting and is read more as a pair of semi detached properties. Numbers 92 to 96 are read as a group of three. The buildings are of a smaller scale and comprise more of a cottage style with horizontal emphasis fenestration. This contrasts with 100 to 102 which have a more formal appearance. Chequer red brickwork, keystones and stone lintels provide a classical character and have greater prominence compared to the cottage style.

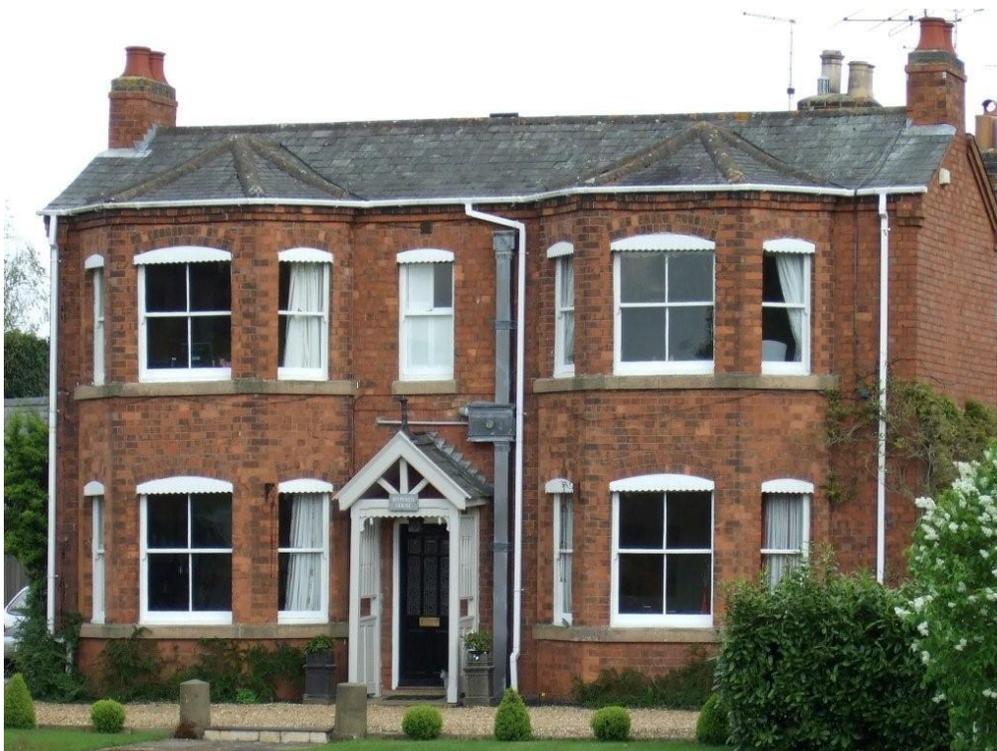
Photograph 9 The end terrace on Main Street

The last in the terrace fronts onto the paddock and faces the River Avon. The facade is symmetrical and comprises two storey bay windows and sash windows. The building has the most prominence appearing from the front to be detached.

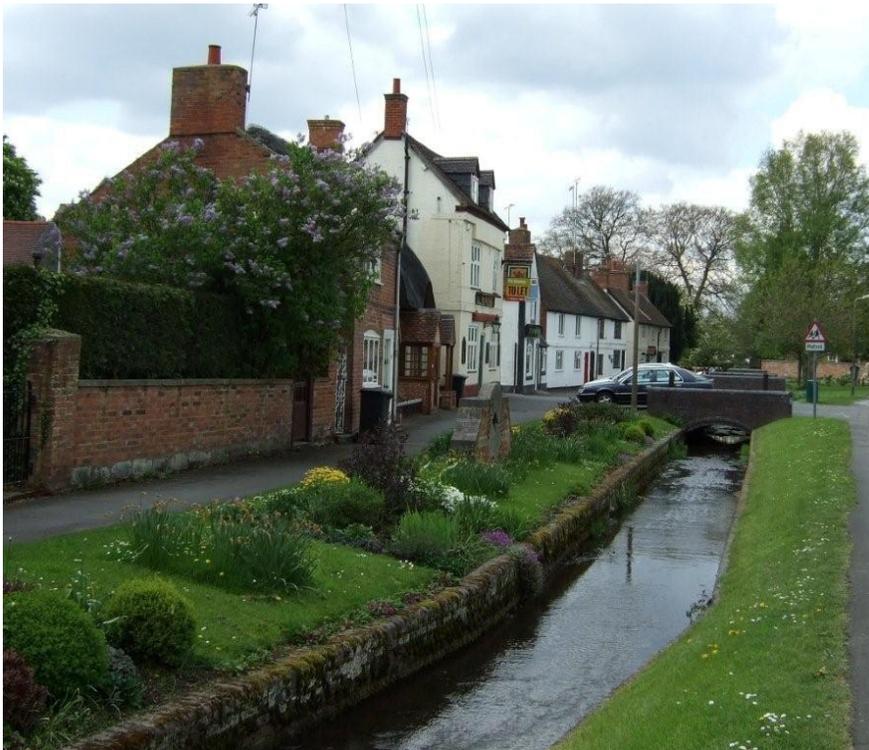
Photograph 10 Buildings set behind village greens

Behind these greens there is no single defining form of architecture. However, the terracing, and adjacent buildings, are read as a group sharing similar characteristics. Behind the village greens they share front building lines and a simple form of architecture. Of two storeys 35 to 37 are semi detached, rendered under a tiled roof. Numbers 29 to 33 are two storey terraces, of white painted brick and a tiled roof. Both buildings have a simple cottage style.

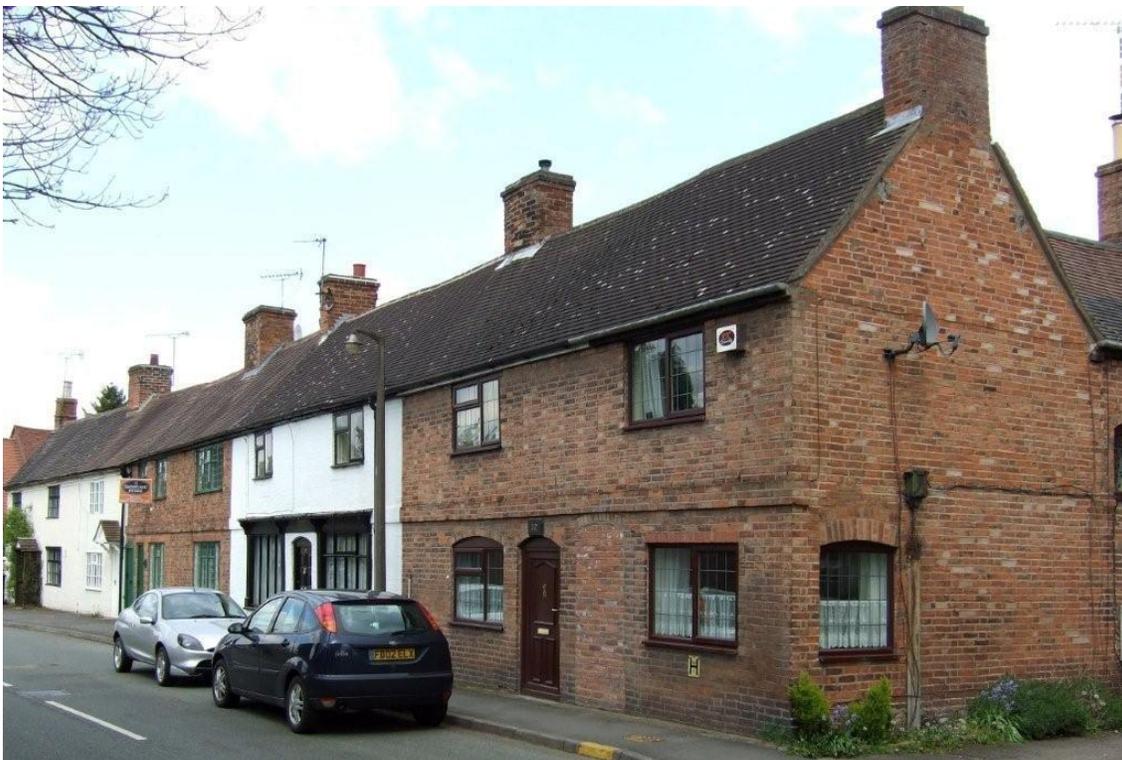
Photograph 11 Terracing on the eastern side of Main Street

Following this simple style is 18 to 26. Two storey and rendered, though painted different colours, the terrace again abuts the road and follows a low key cottage style with small and regular openings.
